NATIONAL TRANSPORTATION SAFETY BOARD

RAILROAD / HIGHWAY ACCIDENT REPORT

**COLLISION OF A SOUTHEASTERN PENNSYLVANIA
TRANSPORTATION AUTHORITY COMMUTER TRAIN
WITH A GASOLINE TRUCK
SOUTHAMPTON, PENNSYLVANIA
JANUARY 2, 1982**

NTSB-TSR-RHR-82-3

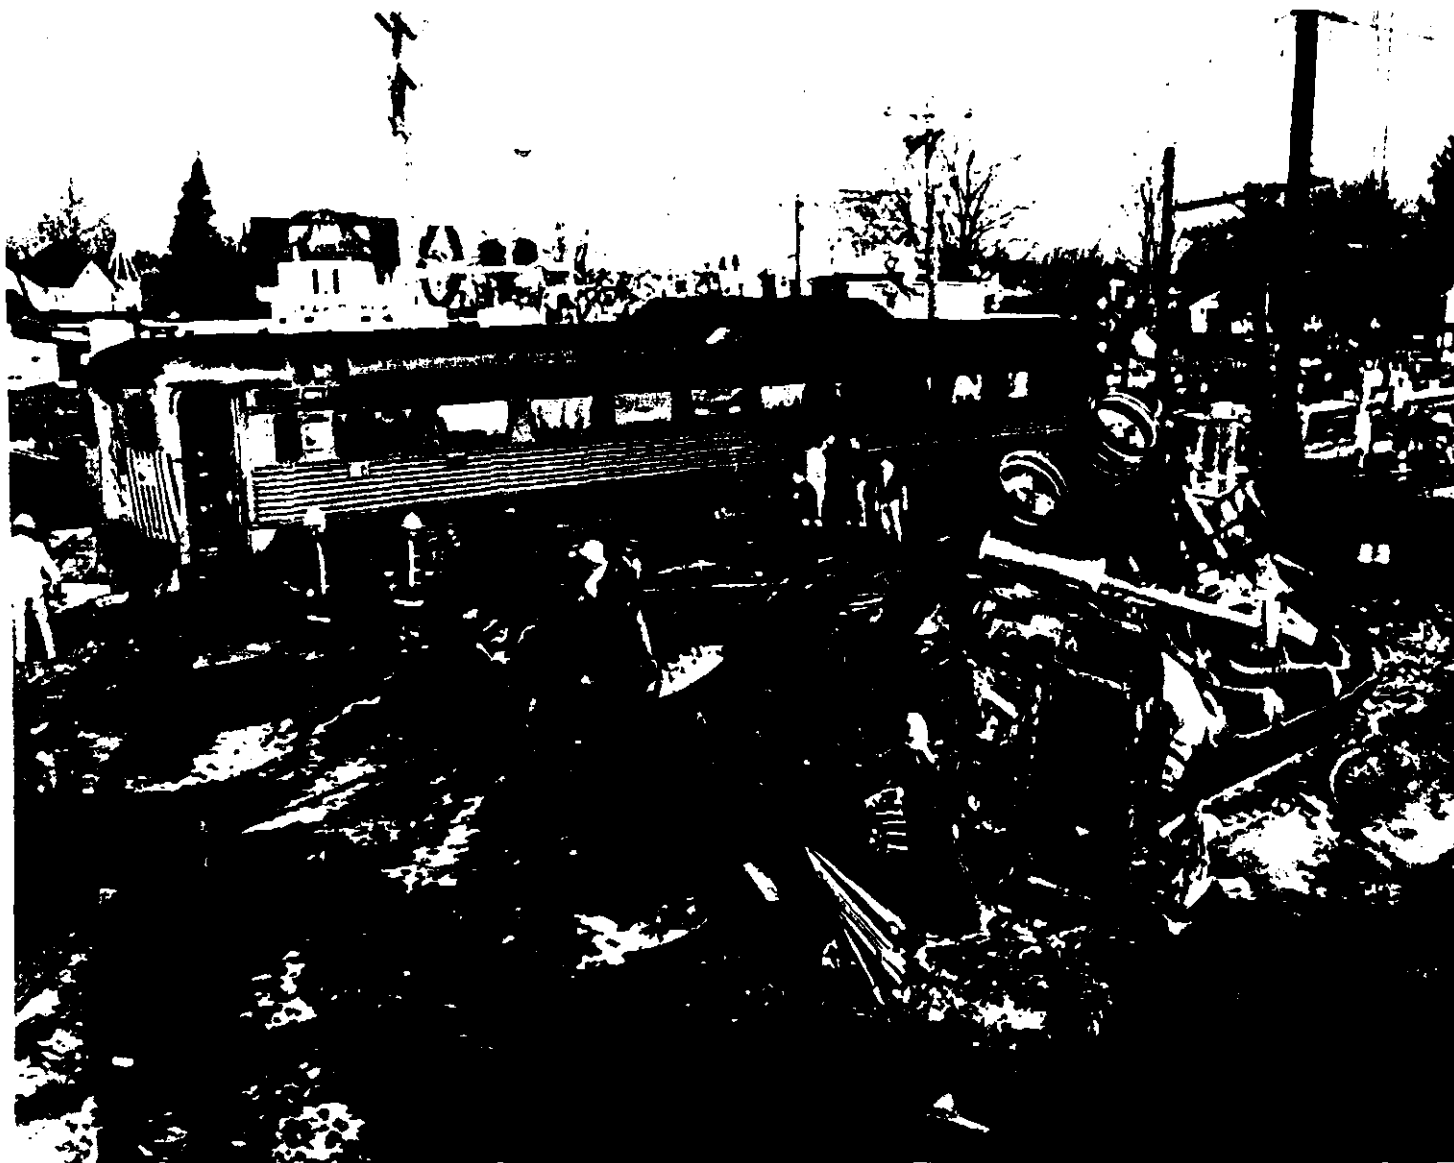
Figure 4.—Accident view looking north on Second Street Pike
from Knowles Road Intersection.

ARCO Truck.--Except for the two front tires, the right fender and door, the body of the Mack tractor was damaged extensively by the rollover and fire. The left rear of the cab was pushed forward and downward. The tractor cab interior was gutted by fire and all the cab window glass was destroyed. The tachograph, rear tires, wiring, and air hoses to the brake chambers, except at the right front, were destroyed by fire. (See figure 4.)

The tandem subframe, at the rear of the right front spring hanger, had an inward vertical crease and a downward buckling. The right front outside and inside wheels were gouged severely in the inside of the tire. A 9- by 3-inch tear was found on the outer rim of the inside wheel. The right center spring hanger bolts were sheared, causing the right side tandem wheels to deform rearward. Damage to the ARCO tractor semitrailer and its cargo was estimated at \$50,000 and \$7,900, respectively.

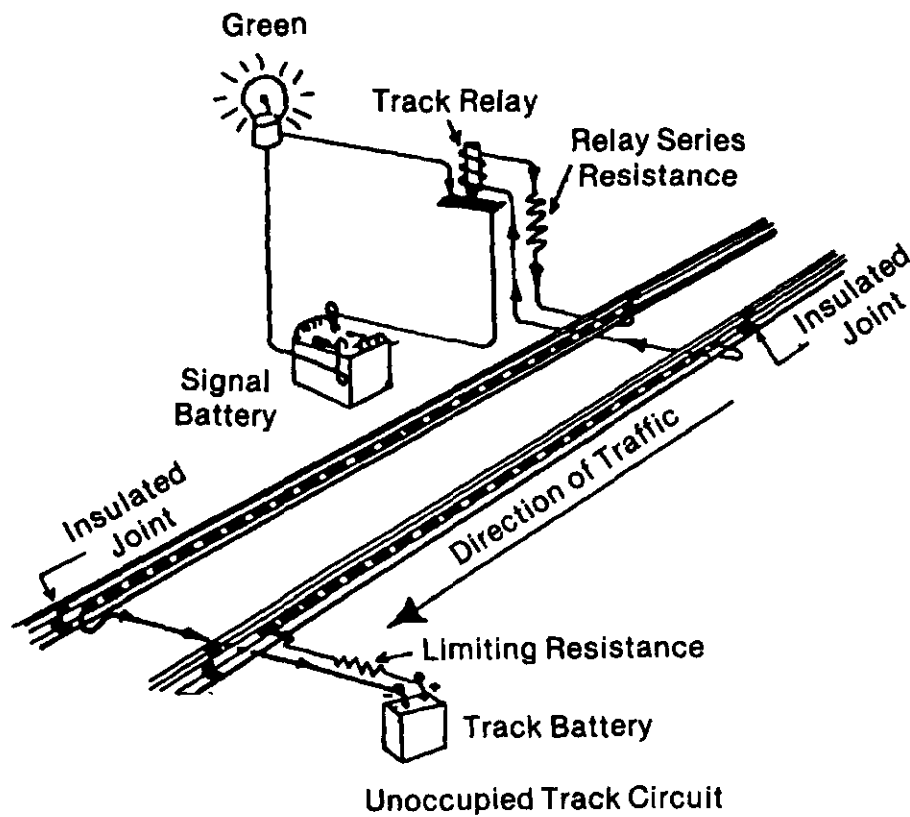
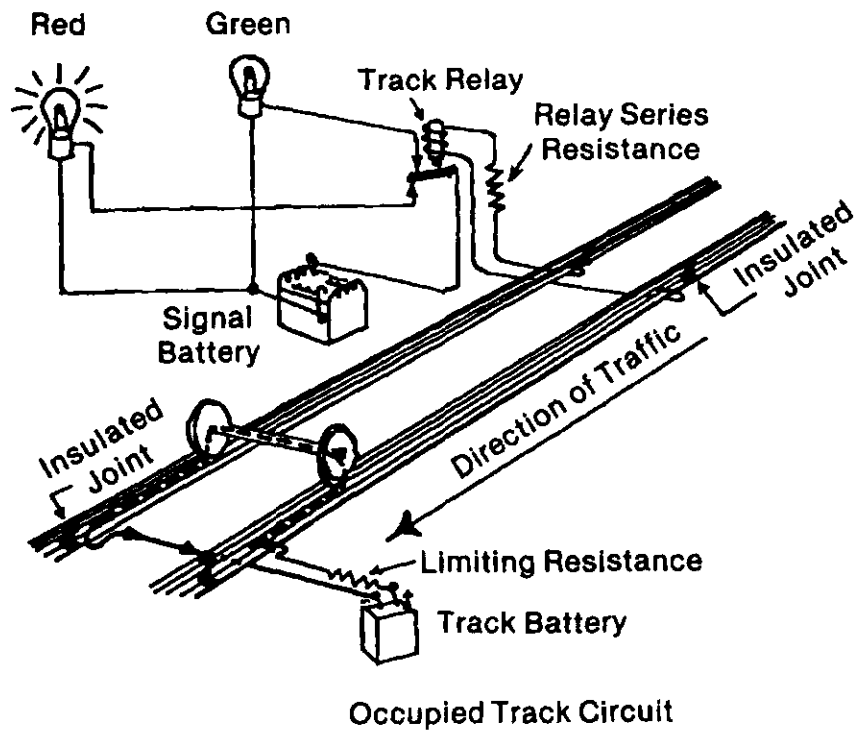
Figure 6.—Sketch of track circuit shunting.

Single rail diesel cars have a history of failure to shunt track circuits because of their light weight. SEPTA and its predecessor, Conrail, were aware of the problem and issued Timetable General Instructions which require single rail diesel cars to approach highway grade crossings prepared to stop unless the automatic grade crossing protection is known to be working. Also, railroads have taken other measures to improve the ability of single rail diesel cars to shunt track circuits. Because the Budd rail diesel cars operated by SEPTA are equipped with disc brakes, the cars also are equipped with wheel scrubbers designed to free the wheel tread of dirt and provide a better electrical contact with the rail. However, due to the cars' light weight, train No. 114 apparently did not hold a constant shunt, most likely due to the nonuse of the track during the day before the accident and the possibility of a film of dirt and rust building upon the rails from frost and dew.

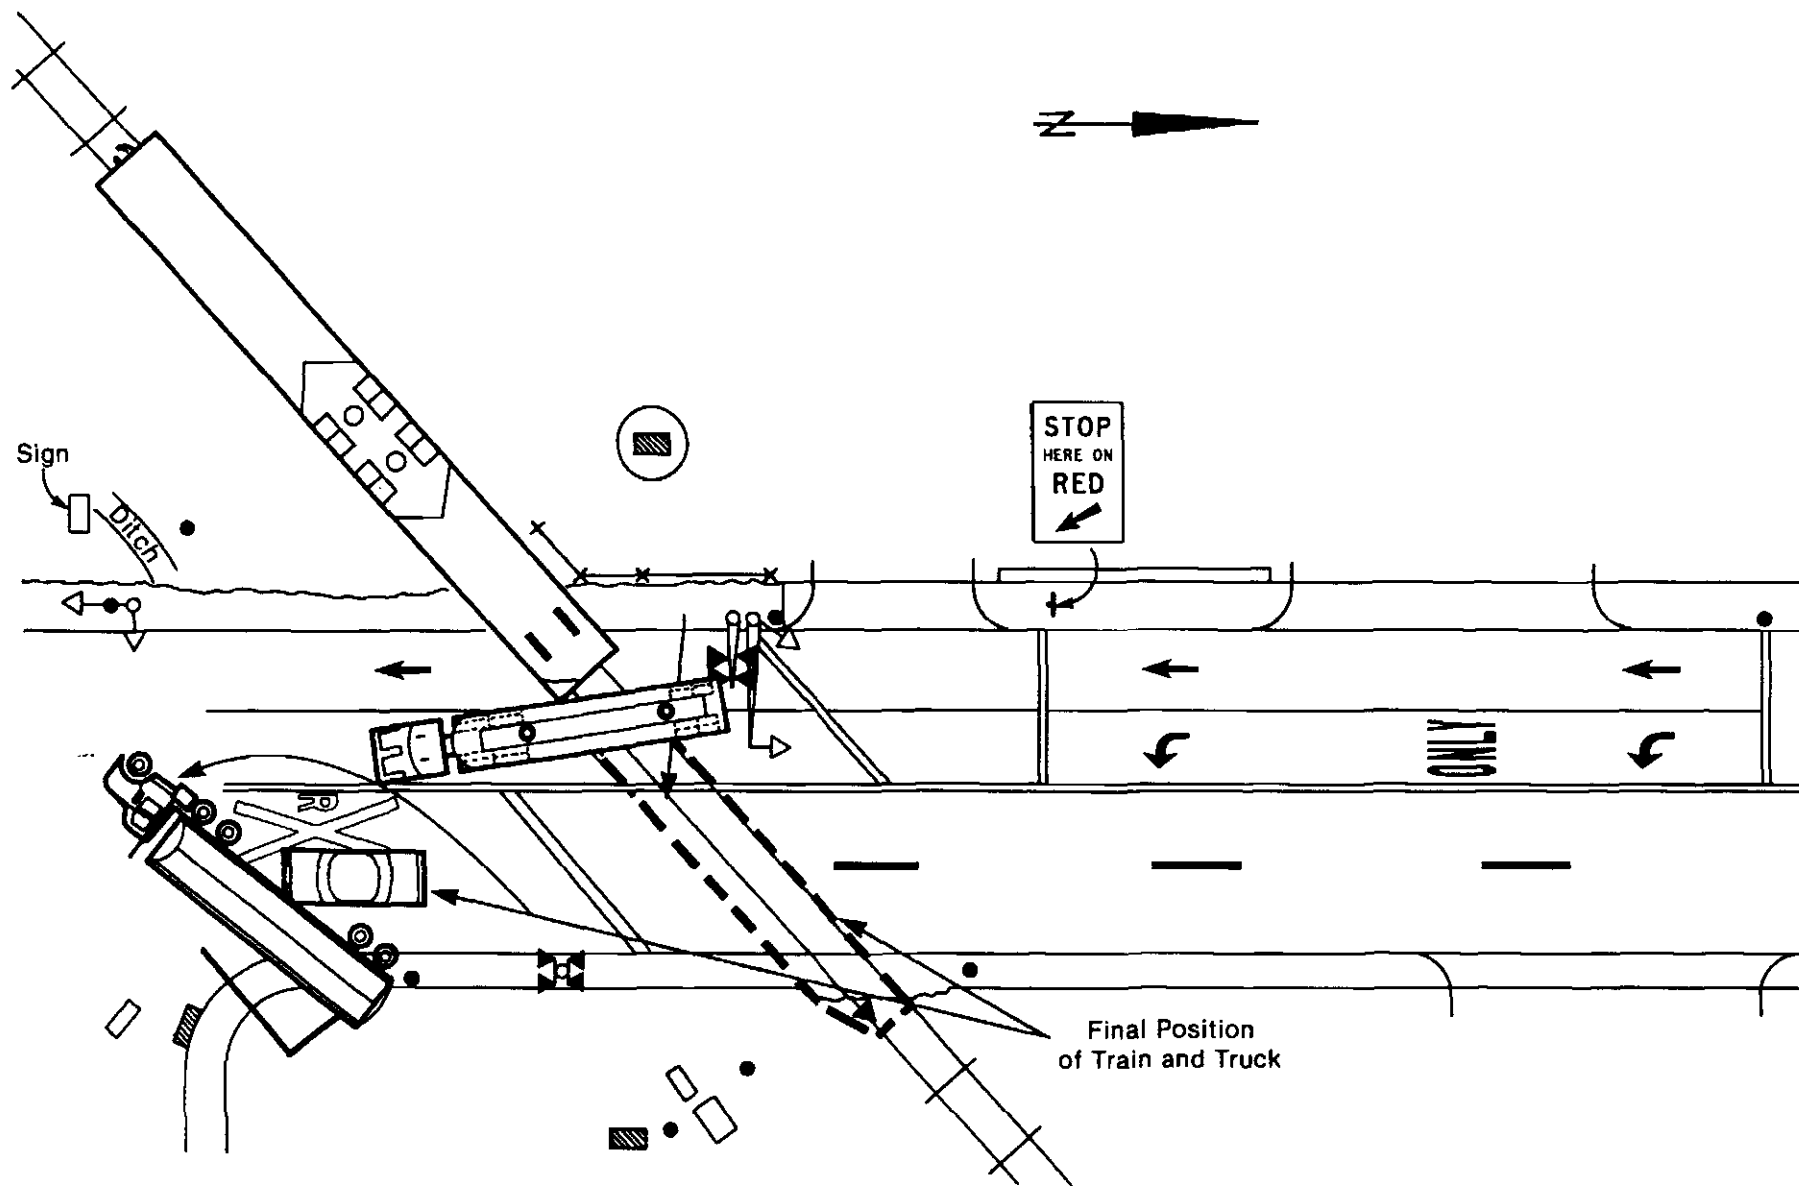
Figure 10.—Sketch of approximate initial impact.

The train approached the crossing at an angle of $131^{\circ} 49'$ in the northwest quadrant. After impact, the train's front truck derailed and came to rest about 2 feet 4 inches from the rail. Thus, the lateral center of gravity was about 1 foot 2 inches from the track. The train moved about 14 feet after impact and then derailed, causing the 43-foot long gouge marks in the crossing timbers before coming to a stop.
