NATIONAL TRANSPORTATION SAFETY BOARD

RAILROAD / HIGHWAY ACCIDENT REPORT

**COLLISION OF A SOUTHEASTERN PENNSYLVANIA
TRANSPORTATION AUTHORITY COMMUTER TRAIN
WITH A GASOLINE TRUCK
SOUTHAMPTON, PENNSYLVANIA
JANUARY 2, 1982**

NTSB-TSR-RHR-82-3

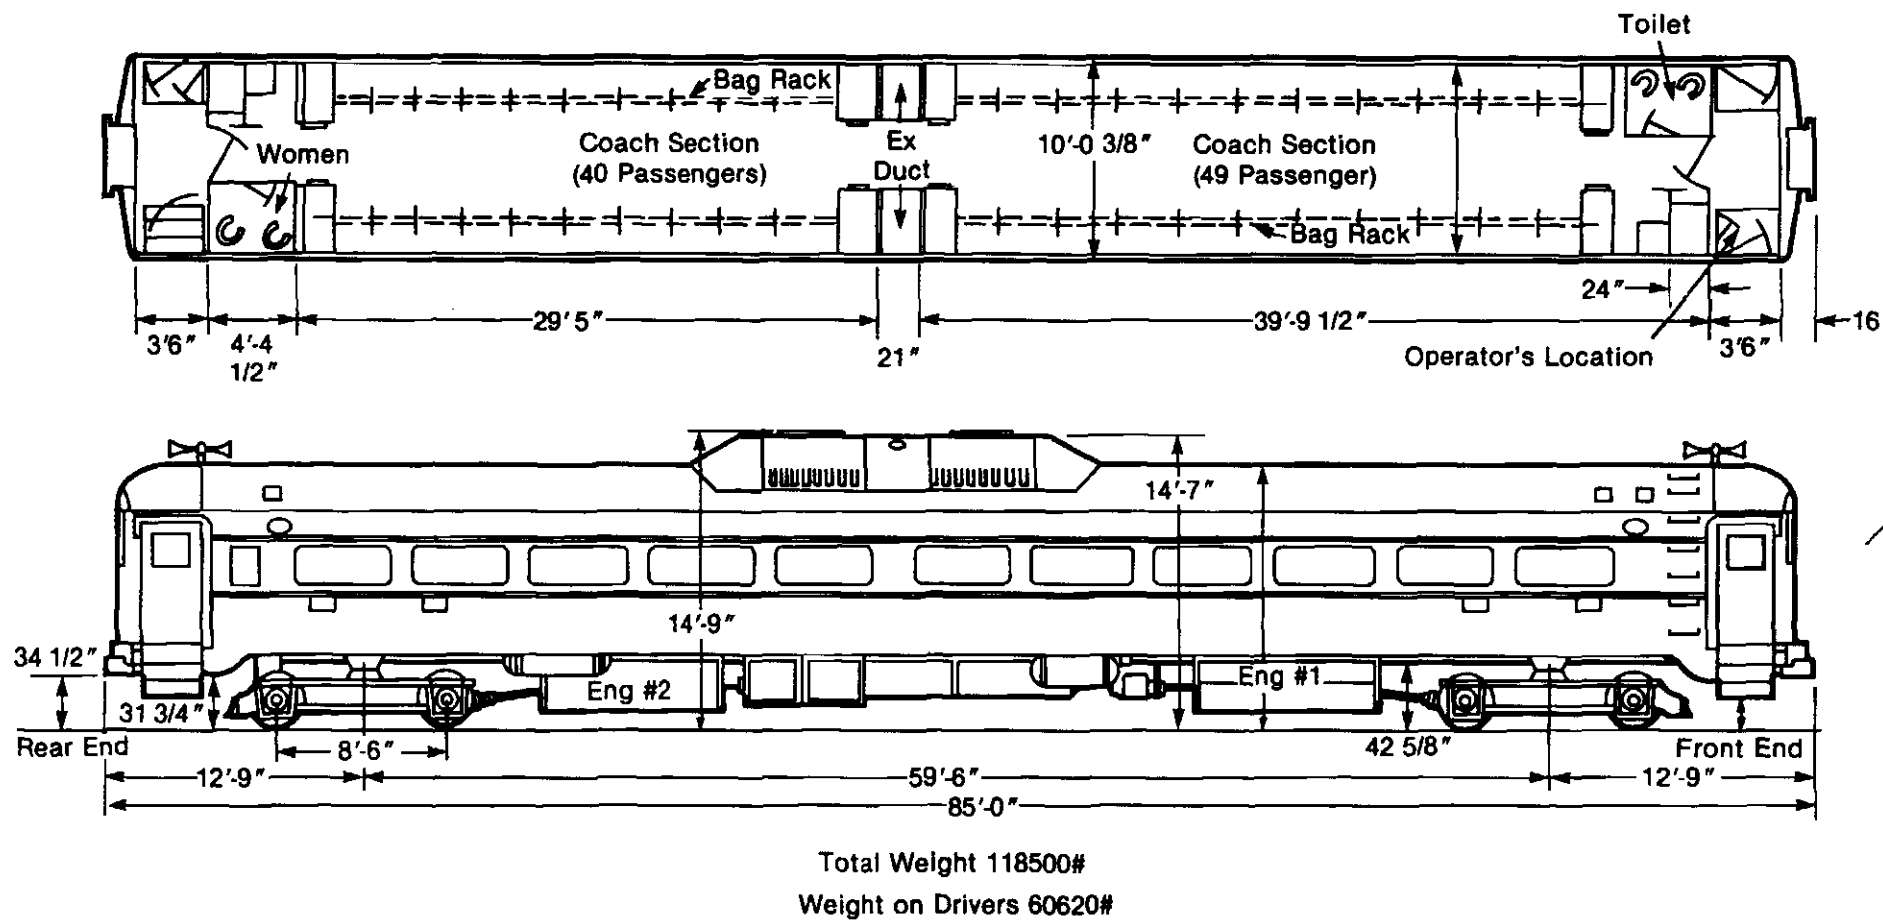
Figure 7.—Sketch of rail diesel car.

The car, powered by a Detroit diesel engine with a hydraulic torque converter drive developing 300 horsepower, was equipped with a 26RL New York air brake system with inboard Budd Company disc-type brakes on the wheels. The car was 85 feet long, 10 feet 4 9/16 inches wide, and 14 feet 9 inches high. The 4-wheel trucks were centered 59 feet, 6 inches apart. The car weighed 118,500 pounds without passengers, seated 89 passengers in walkover seats in a two-by-two configuration, and was divided into two compartments by exhaust ducts on each side of the aisle at the center of the car. (See figure 7.)
